STRUCTURAL CONDITION ASSESSMENT REPORT FOR
THE GRANARY ELEVATOR BUILDING
PHASE II – FOUNDATION EVALUATION
Sturgeon Bay, Wisconsin
MBJ Commission No. W13-314.1

STRUCTURAL CONDITION ASSESSMENT REPORT FOR
THE GRANARY ELEVATOR BUILDING
PHASE II – FOUNDATION EVALUATION
Sturgeon Bay, Wisconsin

Date: November 25, 2013 (*revised December 12, 2013*)

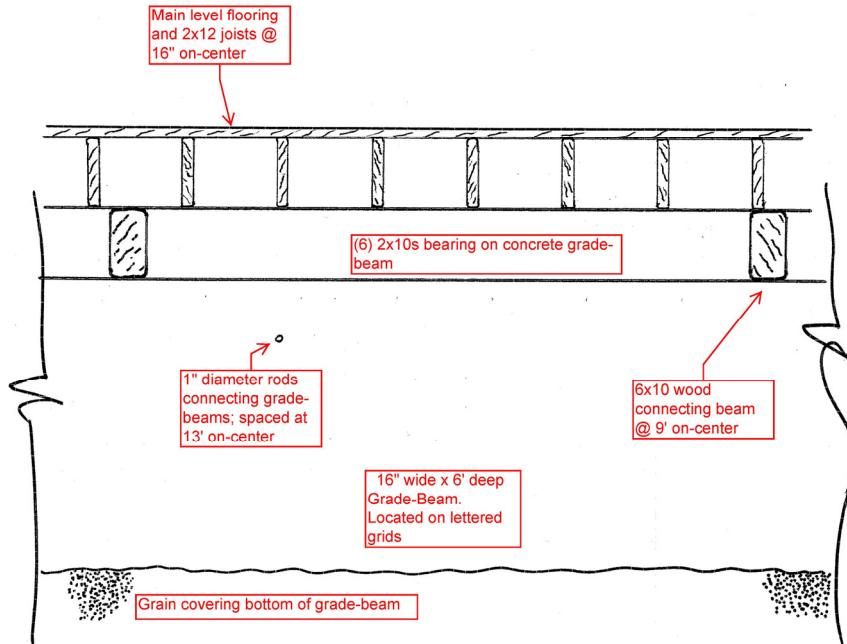
Diagram 2: Elevation of a grade-beam

The July observations created the perception that relatively shallow grade-beams supported the building, and that a shallow crawlspace existed in the northwest corner of the building. The recent site visit uncovered that this is not the case. The foundation consists of 16" wide by 6'-0" deep concrete grade-beams that lie on the north/south lettered grids. A composite 12x10 wood beam (six 2x10s) bears on the grade-beam; 2x12 wood floor joists spaced at 16" on-center span across the composite beam. The building columns bear atop the grade-beams; it is not clear whether the columns bear directly on the concrete or sit atop the 12x10 wood beam. The grade-beams are tied together by 1" diameter rods that span east/west and are bolted to the grade-beams at approximately 9" below the top of concrete. Parallel to the rods, 6x10 wood beams spaced at 9' on-center also tie the top of the grade-beams together. See Diagram 2 and Photo 2. The grade-beams bear on wood piles driven to competent soils.

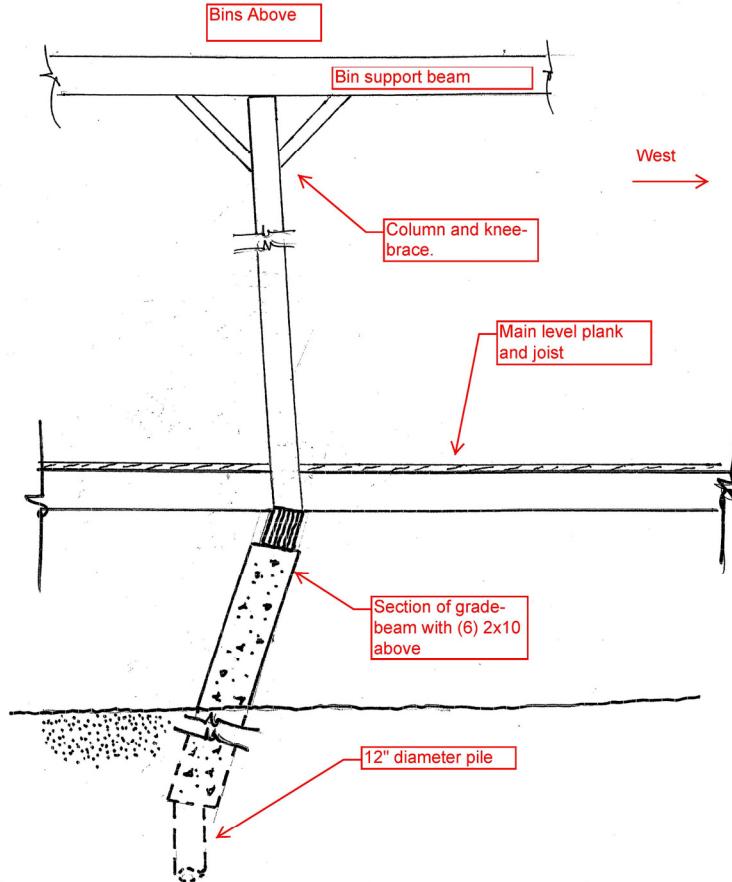
Diagram 3: Section of grade-beam

The east/west tilt of the building has caused the tops of the grade-beams to rotate several inches to the west. The extent of deflection varies across the building. The outside grade-beams (on grids A and E) are sloped only a few inches, while the interior grade-beams have greater deflections. The north and south ends of the interior grade-beams (B-D) are separated from the middle 18' of the beams, near grids 3 and 5, by a construction joint. The grade-beams between the joints are rotated approximately 21" to the west (16 degrees); the grade-beams to the north and south are deflected approximately 6" to the west (5 degrees). See Diagram 3 and Photo 3.

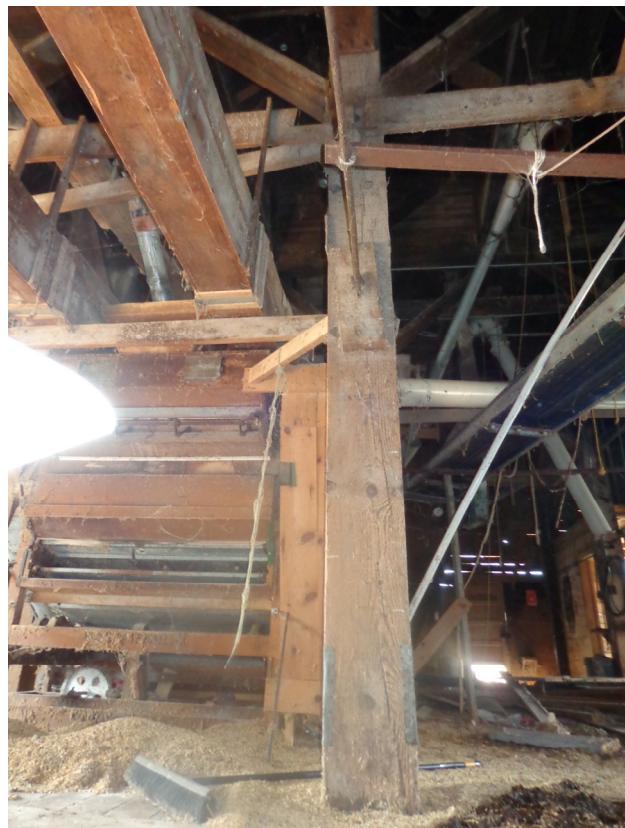
The main floor of the elevator consists of wood planks that bear on wood joists, spaced at 16" on-center. The joists bear on concrete grade-beams, located on the lettered grids. Thirty 12"x12" wood columns extend from the foundation to support the bins. The top-of-column connections include 12"x2 1/2" knee-braces that provide rotational resistance. See photo 1.

Photo 1: Main level column and beams

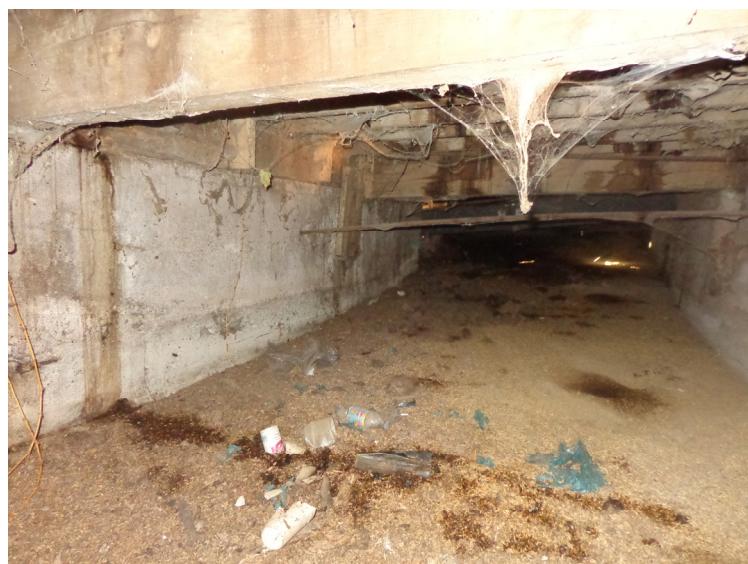
Photo 2: Foundation grade-beams & tension rod in the distance

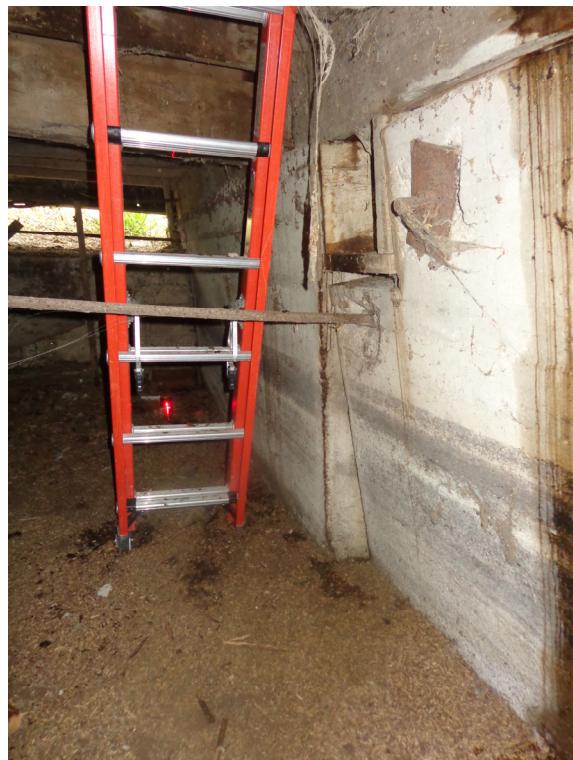
The interior grade-beams (grids A-C) are divided by construction joints at approximately 1/3 points along their length. They are rotated 15 degrees between the joints, and five degrees at the ends of the grade-beams. There is no additional damage to the grade-beams. The tops of the wood piles lie below the water-table and are not subjected to cyclical wetting and drying; therefore, there is insufficient oxygen to allow deterioration due to decay fungi or insect infestation.

Photo 3: Broken grade-beam showing 16 degree and 5 degree rotation

Recommendation 2: The actions required to repair the grade-beams are addressed in recommendation 5 below. The wood piles do not require future action.

- a. Install new concrete grade-beams on the numbered grids that tie the existing grade-beam together, and resist additional rotation. This would require 25 grade-beams (the grade-beams on grid 6 are intact); preliminary calculations indicate that these beams could be 10" wide x 30" deep beams, with (6) #5 horizontal reinforcing bars, and #3 closed stirrups spaced at 16" on-center.
- b. The second system consists of four below-grade buttresses constructed against the west face of the elevator to transfer the east/west wind forces from the foundation to the soils. These could be 10" wide x 30" deep x 36" long, and would include two battered steel helical piers (driven into the soil at an angle).

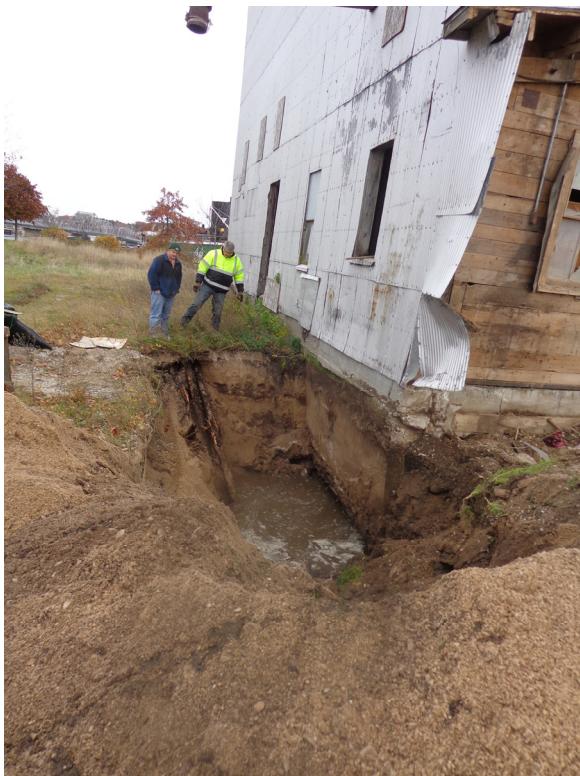
The excavation at the southwest corner of the building exposed the bottom of the westernmost grade-beam, a 5" thick wood beam beneath the grade-beam, and the top 6" of two 12" diameter wood piles. These piles are spaced 5' on-center. The wood piles lie below the water-table and are saturated with water. The excavation removed the water briefly for observation. The exposed portion of the piles were in very good condition, with no visible deterioration. See Photos 4, 5 & 6.

Photo 4: Excavation at southwest corner of elevator

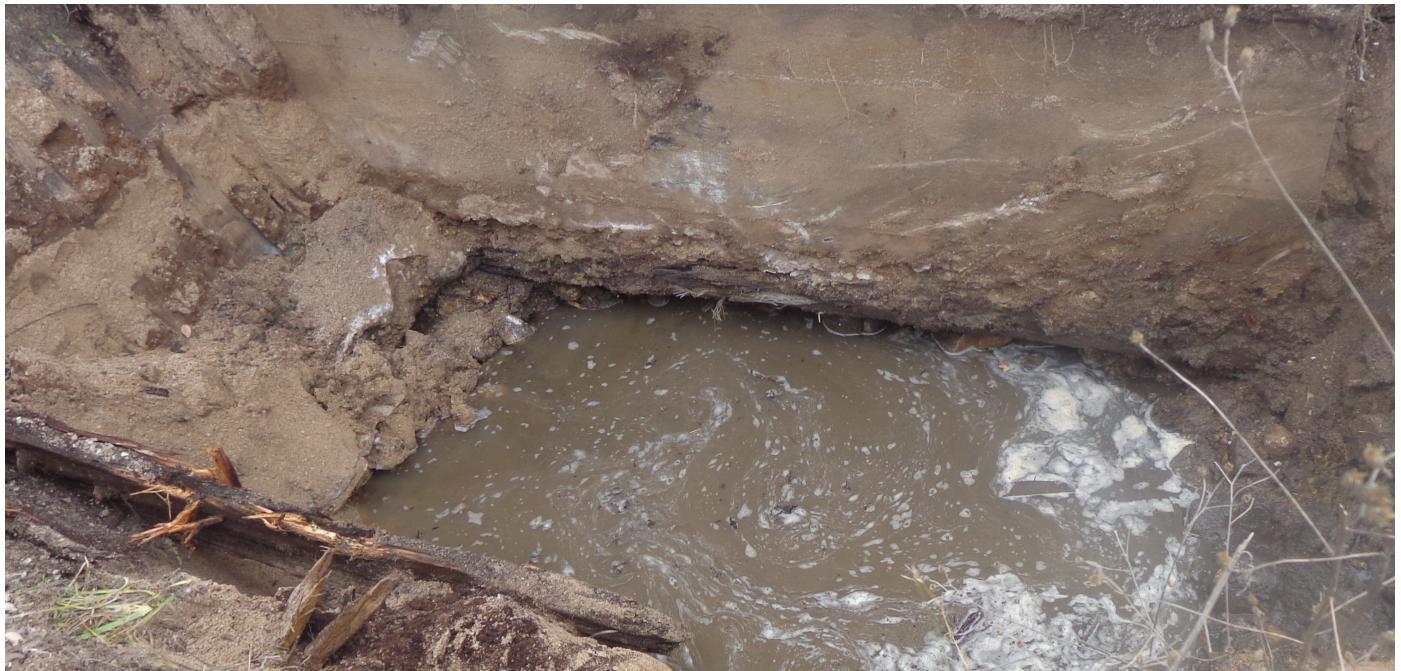
Photo 5: Excavation showing two wood piles

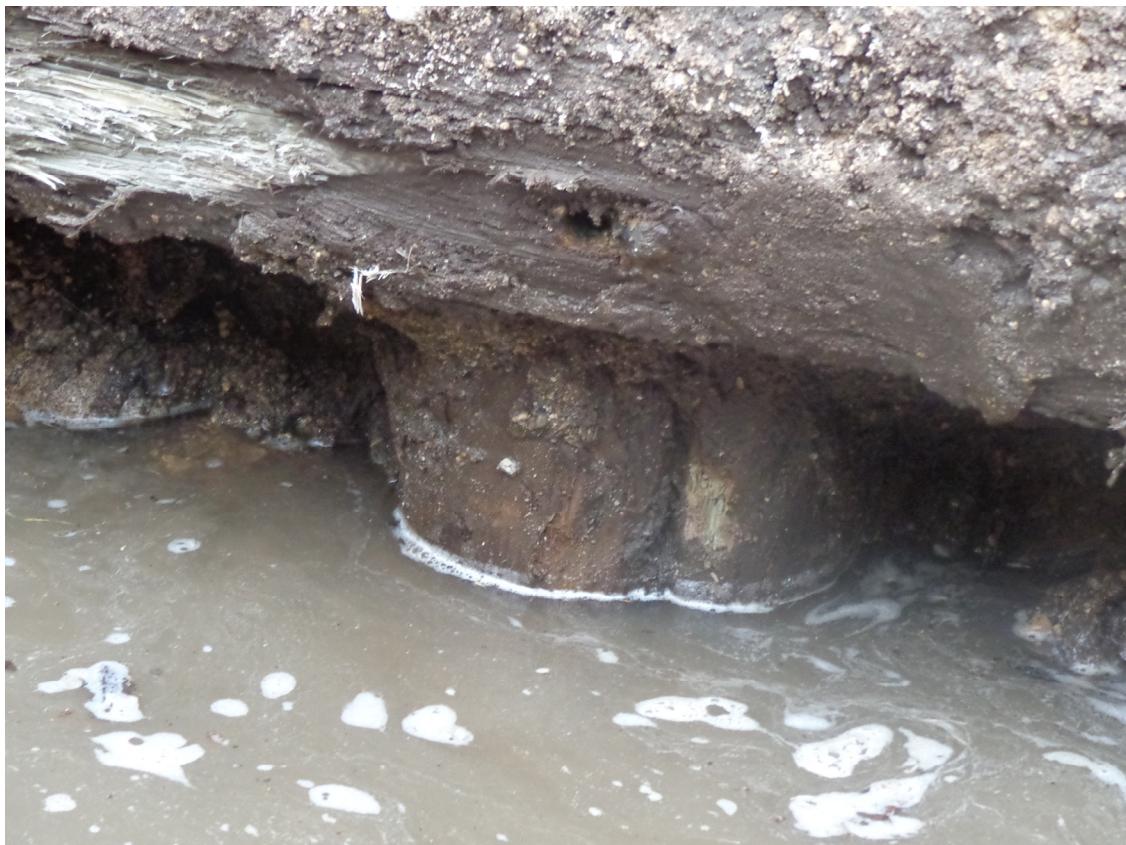
A common problem with historic buildings founded on wood piles is the deterioration of the piles due to attack by decay fungi or insect infiltration. This generally occurs near the top of the piles where the water-table rises and falls cyclically, causing periodic wetting and drying of the piles. Piles that are continuously submerged do not suffer attack due to a lack of oxygen. The excavation of the piles in the southwest corner of the elevator showed that the piles lie below the water-table; the City staff noted that the water level is at an historically low level, which confirms that the piles have remained saturated for the history of the building. This makes a strong case for no past deterioration due to decay fungi or insect attack.

Photo 6: Close-up of wood pile

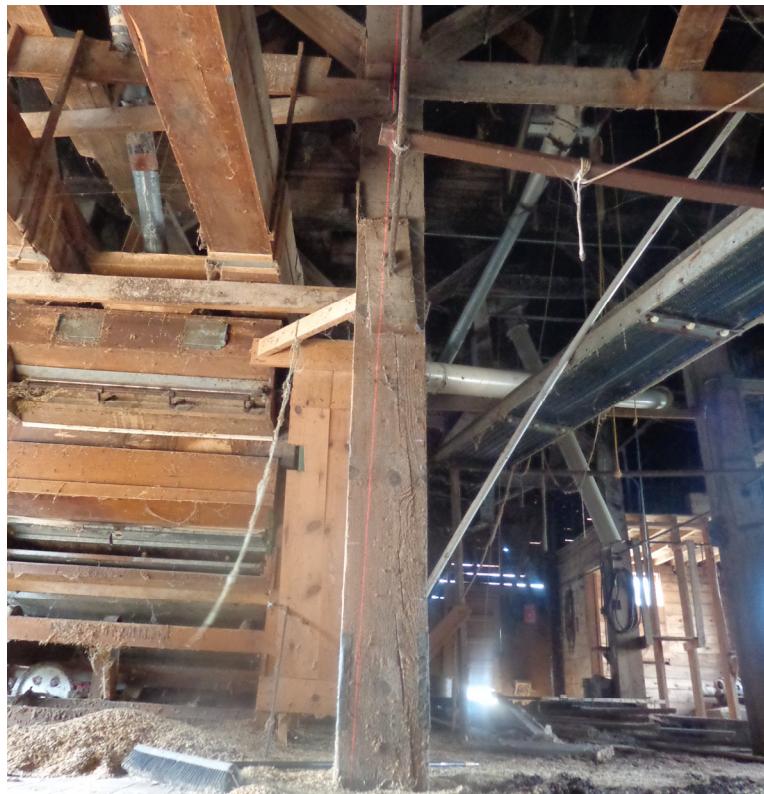
The horizontal deflections are greatest at the interior columns, indicating that the center of the elevator is deflecting in high winds, with the side wall panels working to resist the movement. Over time, the deflections to the west have become permanent, indicating that the original lateral designs were not sufficient. A new system is required to resist the lateral wind forces and the overturning forces caused by the building deflections. See recommendations 4 and 5 below.

Photo 7: Interior column with laser-generated plumb-line showing westward deflection

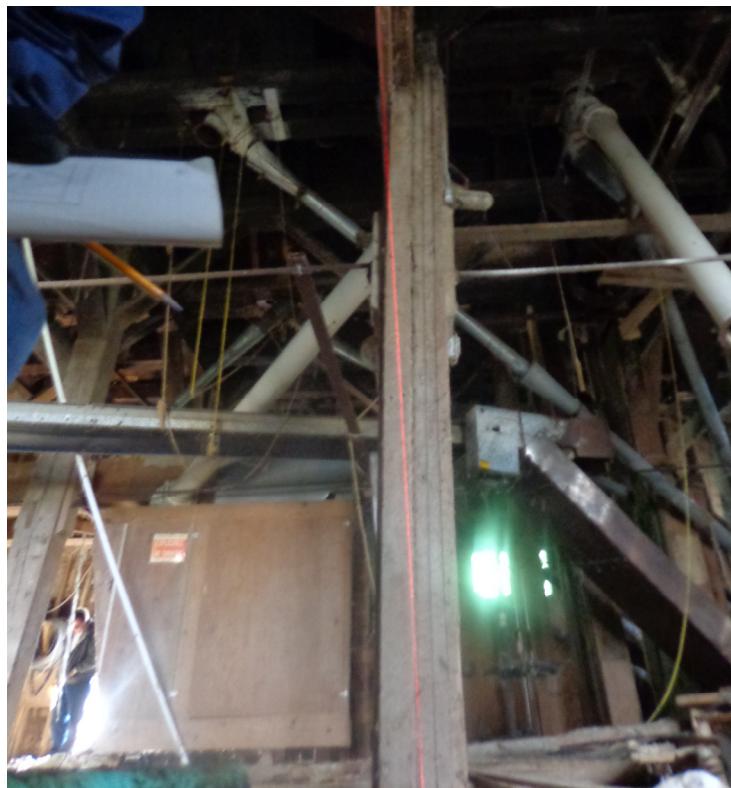
Photo 8: Interior column showing southward deflection

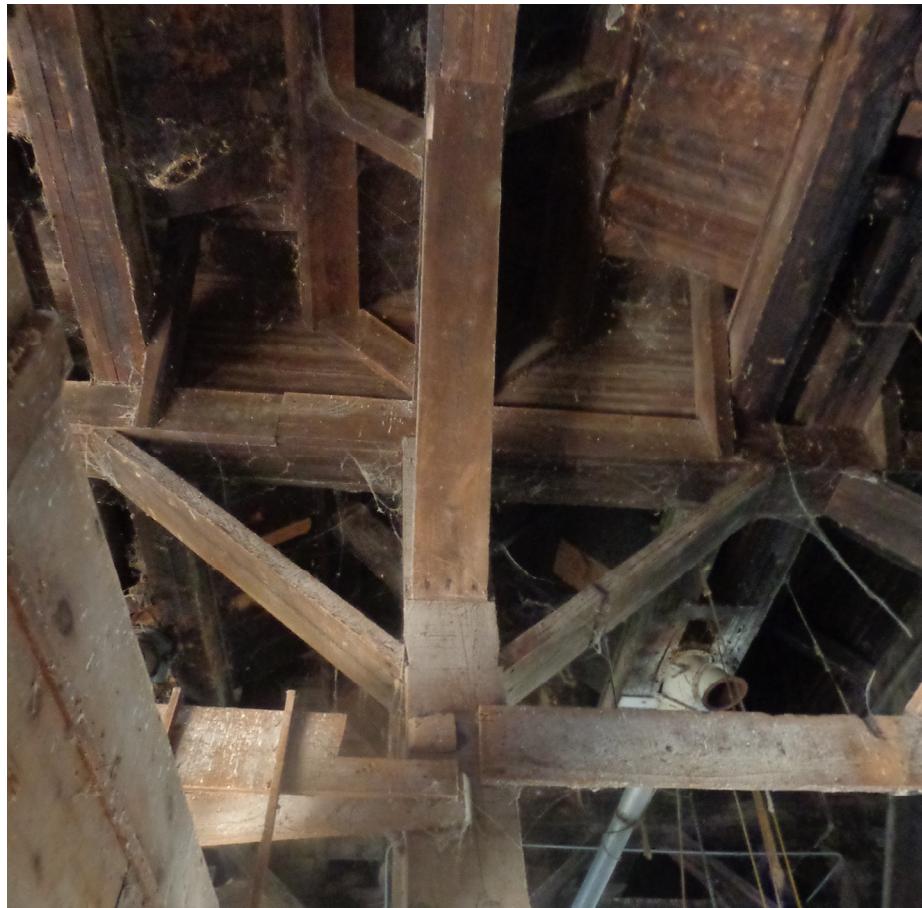
Photo 10: Close-up of knee-brace at top of column

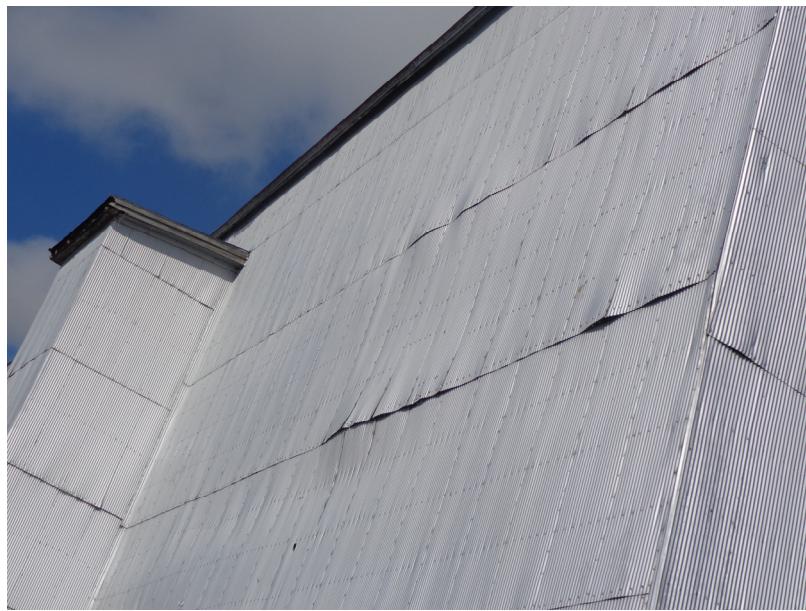
from the bottom of the bins down to the foundation through the corrugated metal exterior walls. These act as stiff vertical shear walls that resist rotation and allow the wind forces to flow down to the foundation. See photo 11.

Photo 11: Corrugated steel cladding
